Marine Survey Prepared for: **xxxxxxx xxxxxxxx**

Vessel: **2002 Hunter 386**

Date: **xxxxxxx xx, 201x**

VESSEL: 2002 Hunter 386

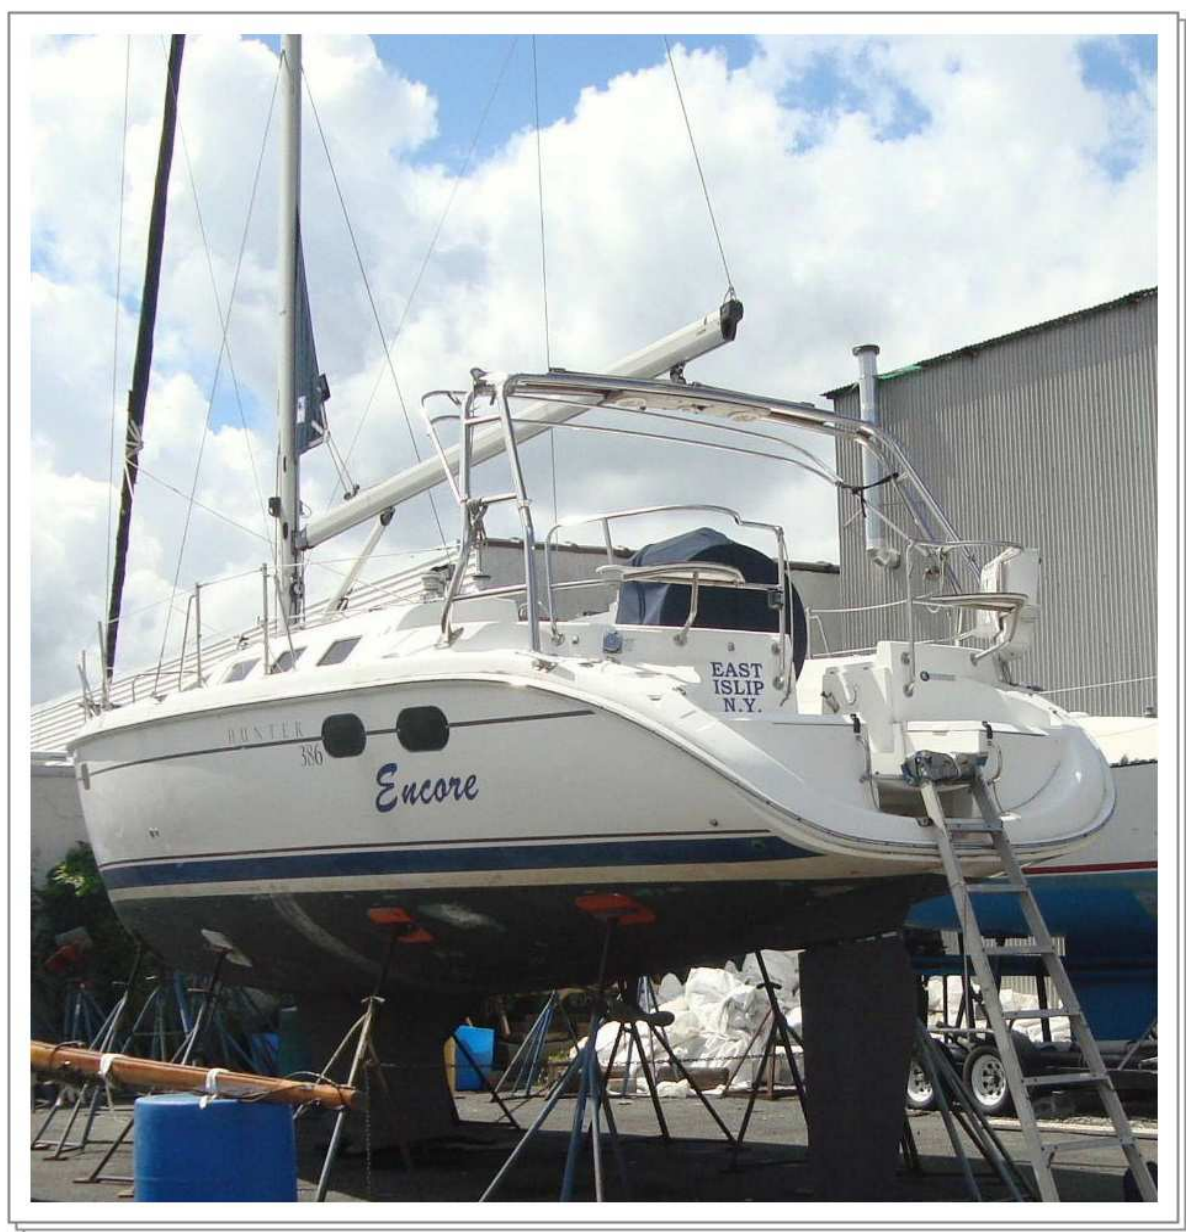
Hull ID# photo redacted

Description: Hull ID#: HUN38xxxxx02 (photograph redacted)
