Frank Abbey Marine Surveyor & Consultant Inc.

Marine Survey Prepared for: **xxxxx xxxxx**

Vessel: **2003 WESMAC Boats Sportfish 42**

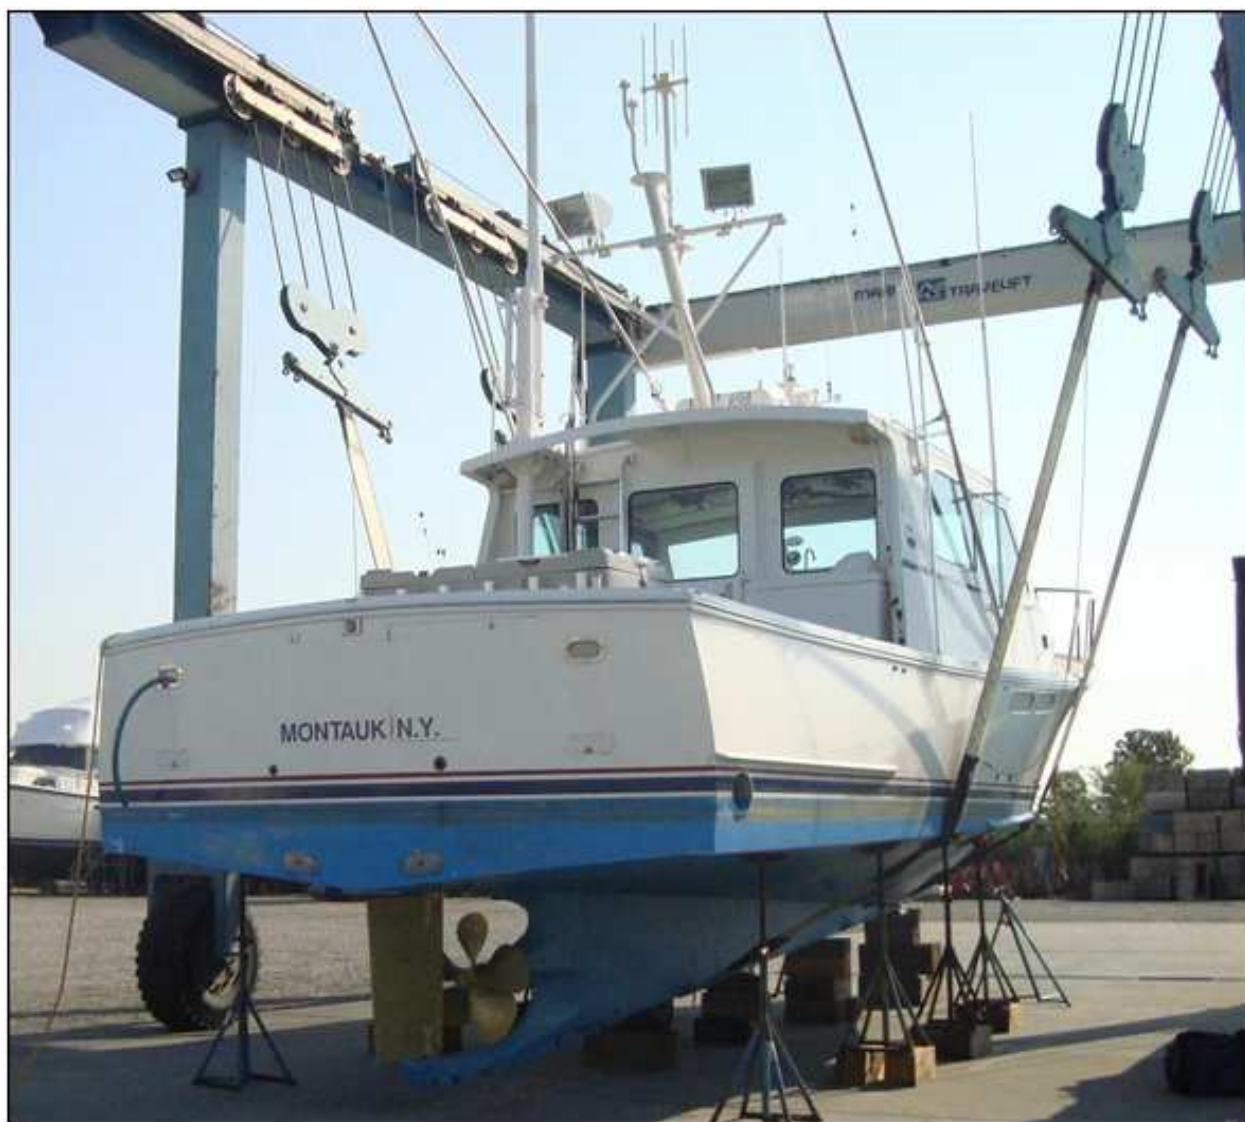
Hull ID# photo redacted

Description: Hull ID#: xxxxxxxxxxxxxx (photograph redacted
