Marine Survey Prepared for: **xxxxxxx xxxxxxxx**

Vessel: **2006 Sea Ray 58 Sedan Bridge**

VESSEL: 2006 Sea Ray 58 Sedan Bridge

Survey; Date & Situation / Location: 7-10-201x; vessel afloat at the dock (systems commissioned); client not attending :: 7-16-2015; vessel on shore (in a travel lift); client not attending and afloat & at a test-run (conducted by Advanced Marine Diesel, VA., engine surveyor); client attending / xxxxxxxx xxxxxxx, xxxxxxxxxx NY (selling dealer).

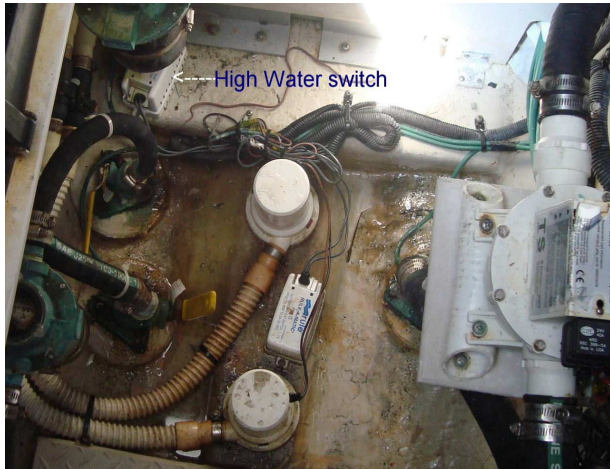
15-- high water bilge pump w/ step float switch (on step up plate; engine space below gen-set platform) tripped its circuit breaker (on main DC panel aft of port engine) when the float switch was lifted. Test all components / wirers of this circuit repair / replace as needed.

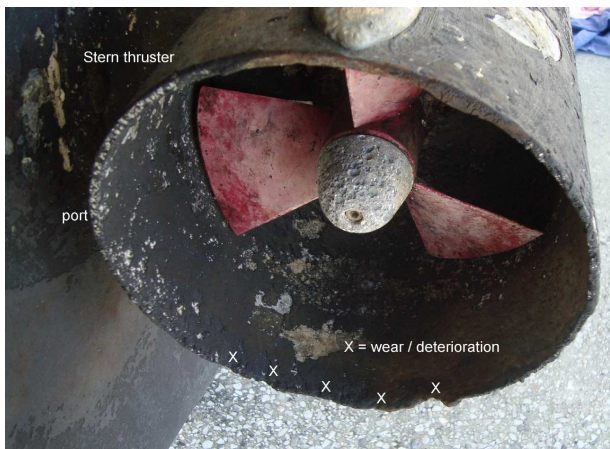
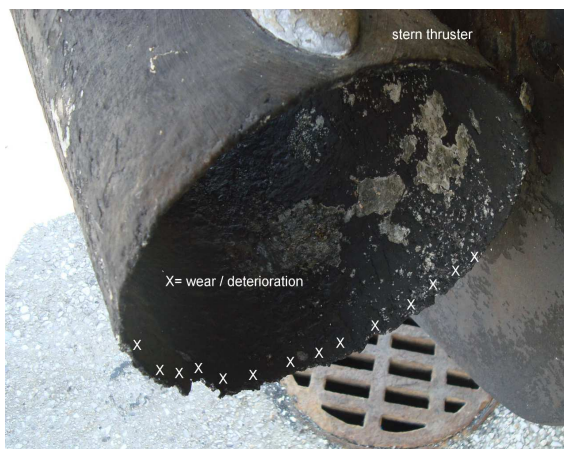
Stern Thruster: Vetus 24v powered; 1- composite 3-blade impeller (appeared sound; no damage evident); thruster metal housing appeared (as sighted / accessed) sound (except as *Note# 16) and tight (via through-bolts) to the transom. Powered on (during docking at the 7-16-15 test-run) and appeared operational.

16-- stern thruster's tube (ss. or aluminum; has multiple layers of anti fouling paint) port & stbd. edges show chipped / worn (appeared due to corrosion activity; stray current / galvanic??). Recommend check bonding system connections; status of on unit zincs; remove all of the anti fouling paint, inspect housing for corrosion / pitting; apply a barrier coat to insulate the metallic tube from any metals / carbon / electrically active compounds in anti-fouling paint. [Note Vessel's shore power input is equipped with an isolation transformer a device that typically prevents "stray current" corrosion.}

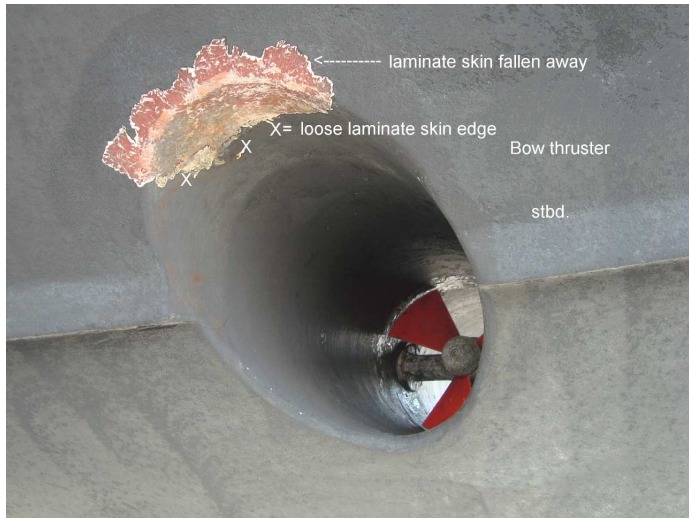
Bow Thruster: Vetus 24v powered; 2- composite 3 blade impellers (appeared sound; no damage evident); thruster tube (frp.) appeared (as sighted / accessed) appeared, neatly faired (except as *Note# 19) and tabbed at the hull. Powered on (during docking at the 7-16-15 test-run) and appeared operational.

19-- stbd. side of bow thruster tube showed missing & loose surface frp. laminate apx. 10" on the circumference x 2" out on the hull surface x 3.5" on the tubes inner surface. (no damage / moisture intrusion / structural delamination evident; loose & missing surface laminate does not appear due to a damage event).
