**Frank Abbey Marine Surveyor & Consultant Inc.**

Marine Survey Prepared for: **xxxxxx xxxxxxxxx**

Vessel: **2008 Chaparral Signature 350**

Date: **xxxx xx, 201x**

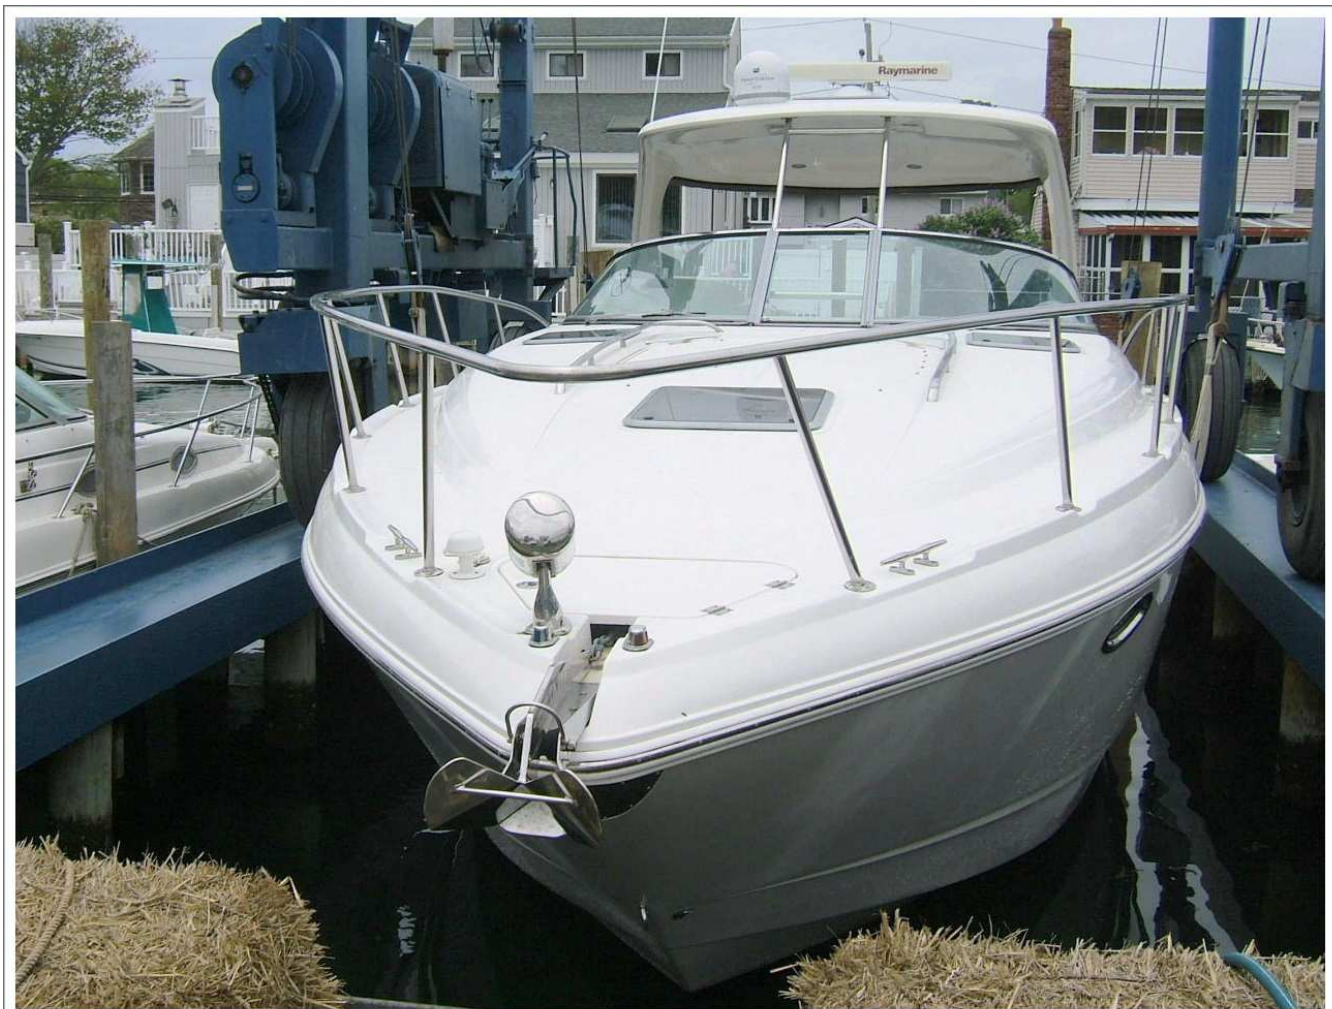
*Hull ID# photo redacted*
