Frank Abbey Marine Surveyor & Consultant Inc.

Marine Survey Prepared for: **xxxxxx xxxxxx**

Vessel: **2009 Sunseeker Manhattan 52**

Survey; Date / Location / Situation: 6-23-2015 / xxxxxxx xxxxxx (selling broker) @ xxxx xxxxxx Marine-xxxxxxx, N.Y. / vessel afloat, at a test-run and hauled (in a travel lift) on-shore; client & their broker and engine surveyor (Engines of NJ LLC. - Pleasantville, NJ; conducted engine survey & test-run) attending;

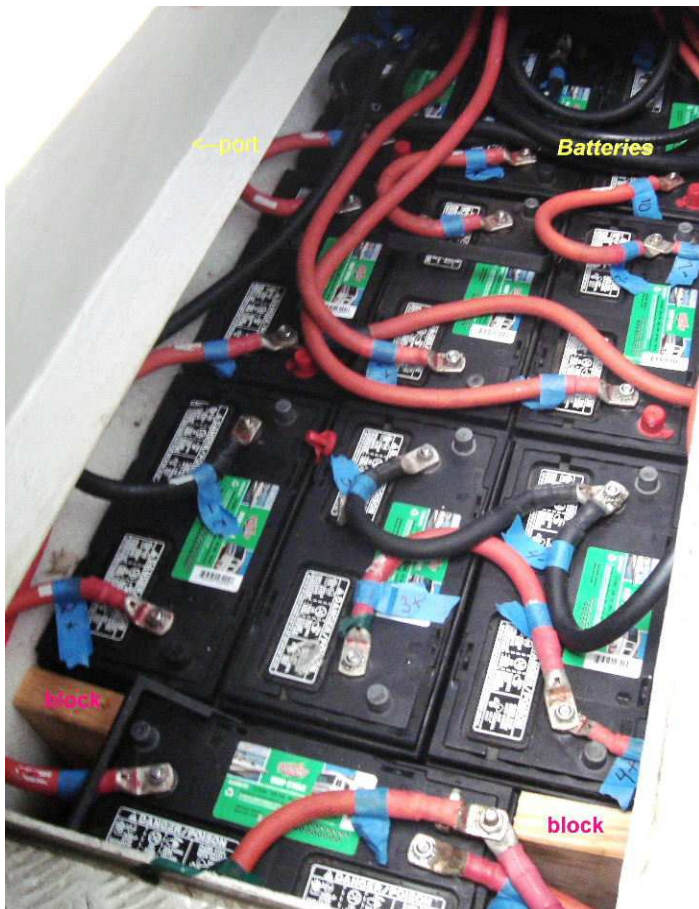
1-- batteries: A) frp. lid covering the battery box (w/ 10 G27 batteries) needs to be secured in place.
B) install (cover on each battery's "+" post.
C) install blocks / brackets to secure each battery from vertical movement (currently installed wood blocks prevent horizontal movement).

ABYC standard: E- 10.7.4: "Each installed battery shall not move more than one inch (25mm) in any direction when a pulling force of 90 pounds (41kg) or twice the battery weight, whichever is less, is applied through the center of gravity of the battery". **E-10.7.7:** "To prevent accidental contact of the ungrounded battery connection to ground, each battery shall be protected so that metallic objects cannot come into contact with the ungrounded battery terminal and uninsulated cell straps."

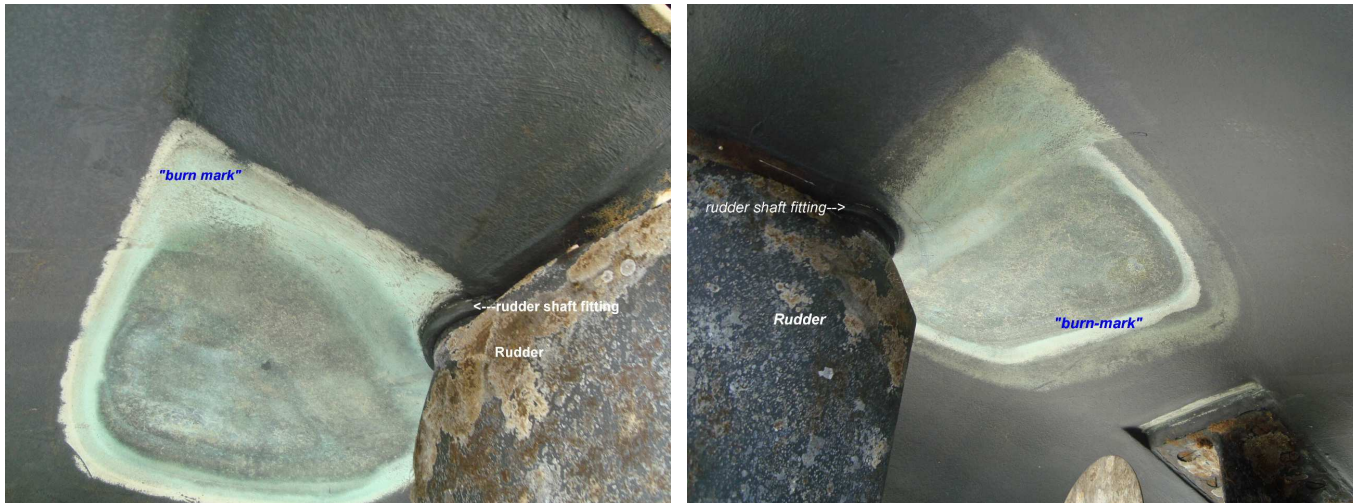
3-- halo apx. 24" dia. of bright green "burn marks" shows on the black anti-fouling paint at / around the two rudder assemblies; indication of stray current / galvanic activity: Vessel needs to be checked for stray-current issues and that the rudder assemblies (could not be sighted / accessed at the survey) are properly connected to the vessel's bonding system and that the bonding system is in proper condition.

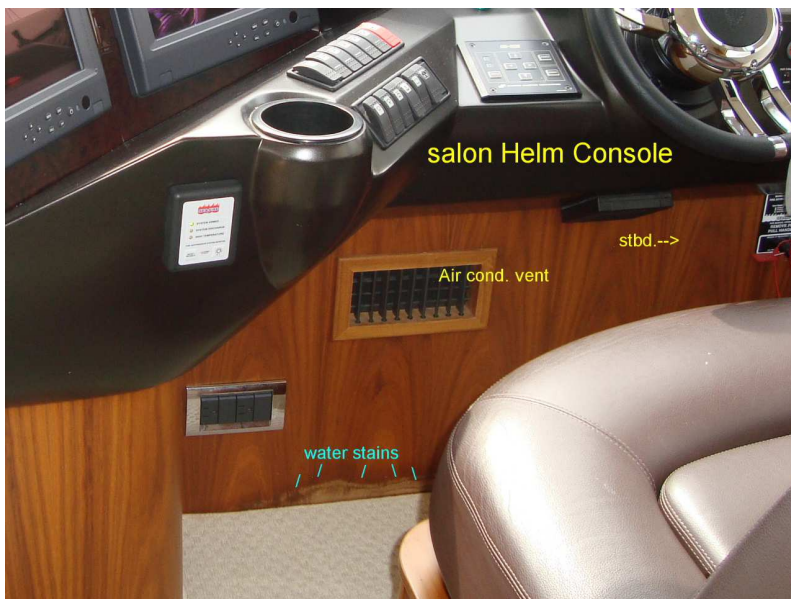
5-- water stains on joinery: A) at the base of the salon helm console (below an air conditioning outlet). B) pilot berth cabin's fwd. locker (appeared as located directly below the noted salon helm issue). (possible cause of the water stains could be condensation from the AC outlet vent & line.)
