Marine Survey Prepared for: **xxxxxx xxxxxx**

Vessel: **2009 Sunseeker Manhattan 52**

-- SURVEY TABLE OF CONTENTS --

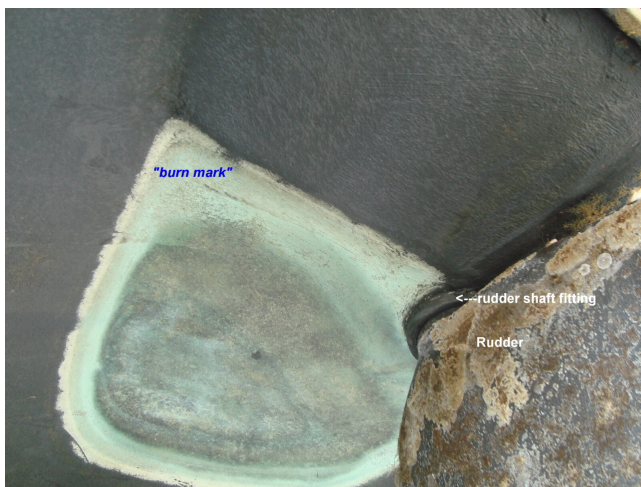
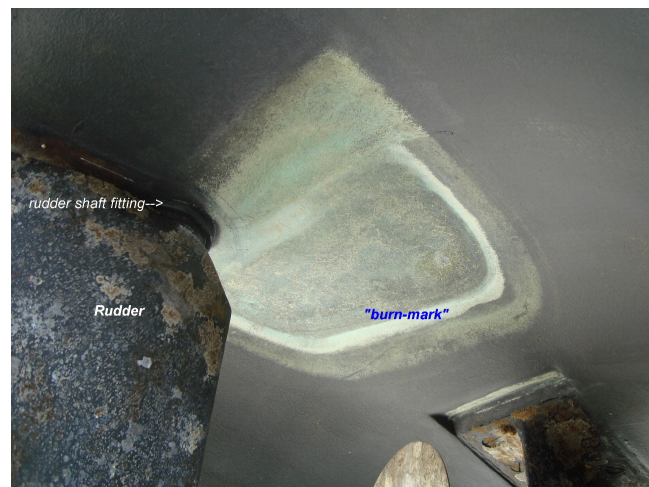
3-- halo apx. 24" dia. of bright green "burn marks" shows on the black anti-fouling paint at / around the two rudder assemblies; indication of stray current / galvanic activity: Vessel needs to be checked for stray-current issues and that the rudder assemblies (could not be sighted / accessed at the survey) are properly connected to the vessel's bonding system and that the bonding system is in proper condition.

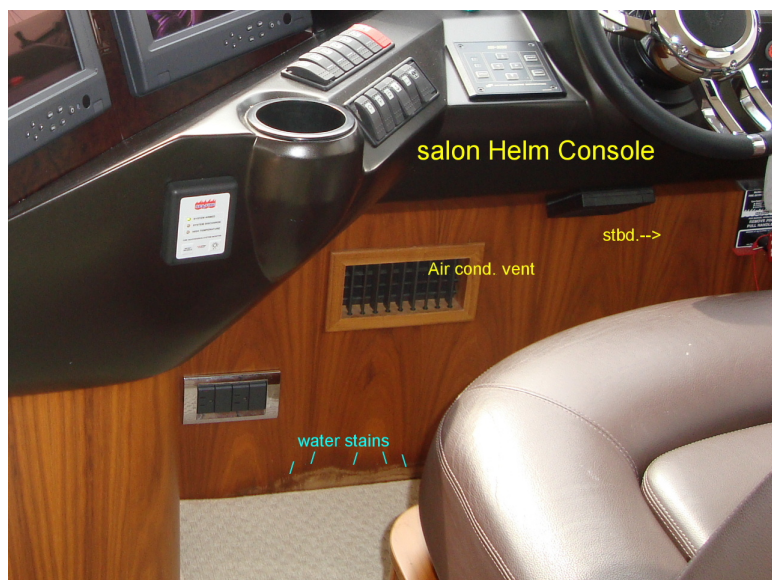
5-- water stains on joinery: A) at the base of the salon helm console (below an air conditioning outlet). B) pilot berth cabin's fwd. locker (appeared as located directly below the noted salon helm issue). (possible cause of the water stains could be condensation from the AC outlet vent & line.)
