**Frank Abbey Marine Surveyor & Consultant Inc.**

Marine Survey Prepared for: **xxxxxx xxxxxxxxx**

Vessel: **2008 Chaparral Signature 350**

Date: **xxxx xx, 201x**

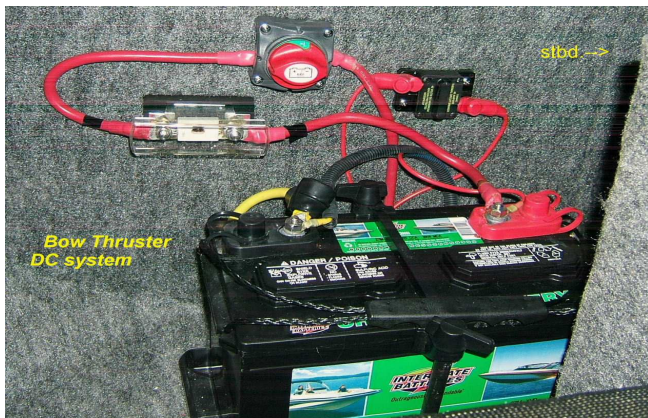
**Bow Thruster:** 12v powered; w/ dedicated battery, in-line high amp fuse & breaker, battery switch and ProTech battery charger (installed aft stb.d under the fwd. berth). Thruster and system components powered on and appeared operational; thruster tube (frp.) appeared (as sighted / accessed) sound and neatly faired to the hull.
